CONTAINER WASHING EQUIPMENT

REAR LOADING. COLD WATER

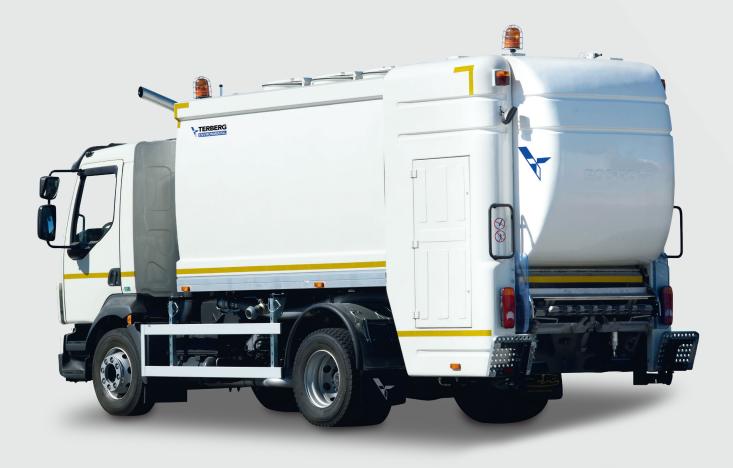
The rear-loading container washing equipment in cold water cleans the bins and containers inside and outside by means of rotating heads and fix bar with nozzles that spray water at high pressure. The container washer is compatible with bins ranging from 80 to 390 liters, flat cover containers with capacities from 500 to 1200 liters and 770 to 1300 liters containers.

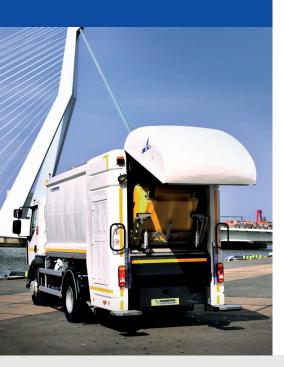
WASHING EQUIPMENT

Cold water
Alternative operating heads	Optional
15 meter hose reel and spray gun	Optional
Sprinkling and flushing equipment	Optional
Detergent dosage equipment	Optional
